# Use of Technology for the Periodic Inspection of Flood Reduction Structures

**Fort Worth District**

**Dam & Levee Safety Program**

**1 December 2011**

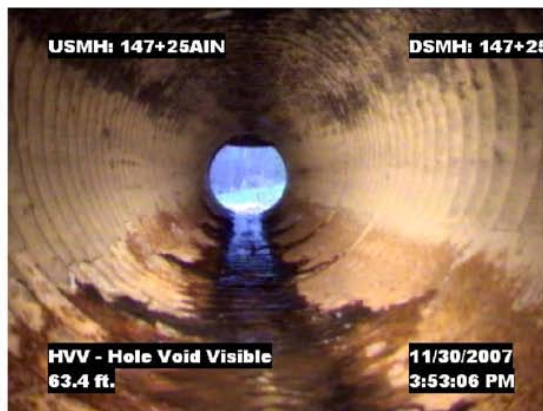
Distance: 63.4 Ft. Grade: 5  
Condition: HVV - Hole Void Visible  
Remarks:

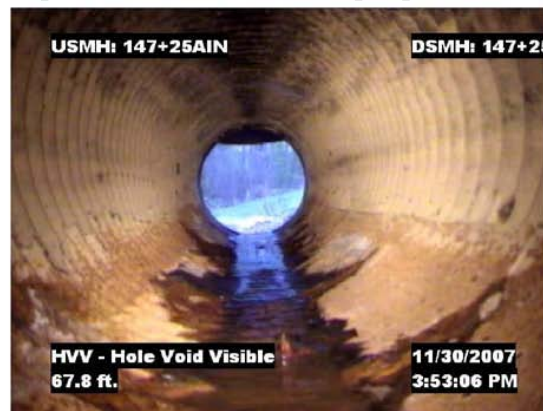
Distance: 67.8 Ft. Grade: 5  
Condition: HVV - Hole Void Visible  
Remarks:

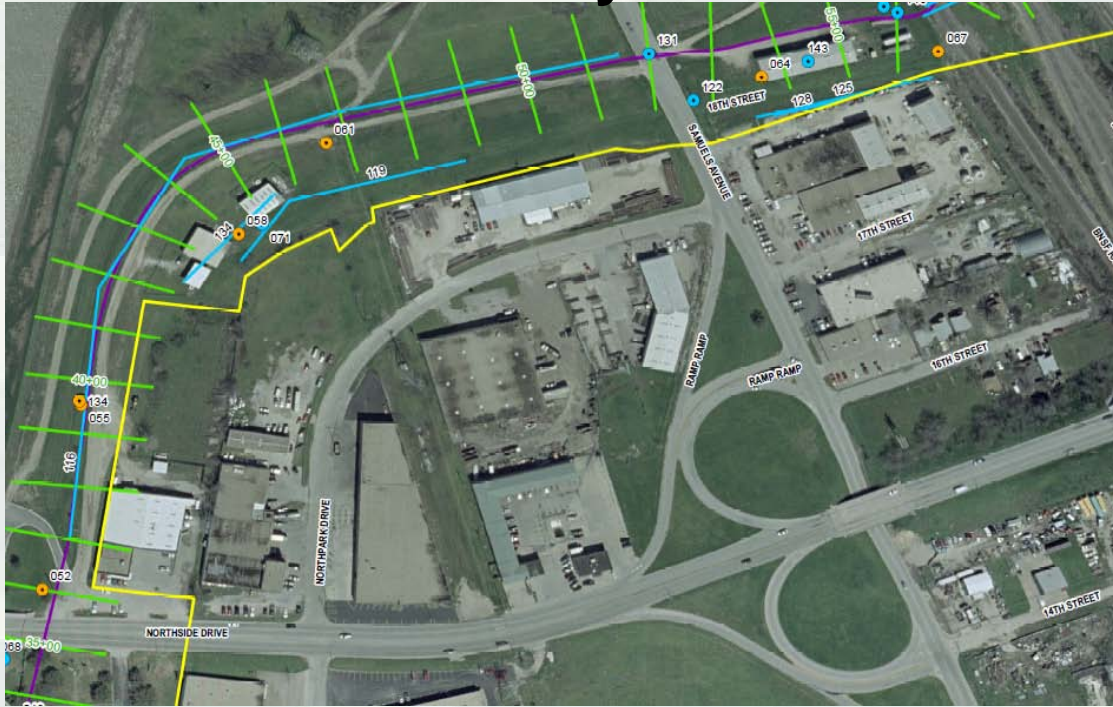
- Private Buildings have been constructed on the levee embankment and adjacent to the levee toe.

- Vegetation/Erosion are common around the buildings.
- Project ROW is not consistent with the as-built plans.

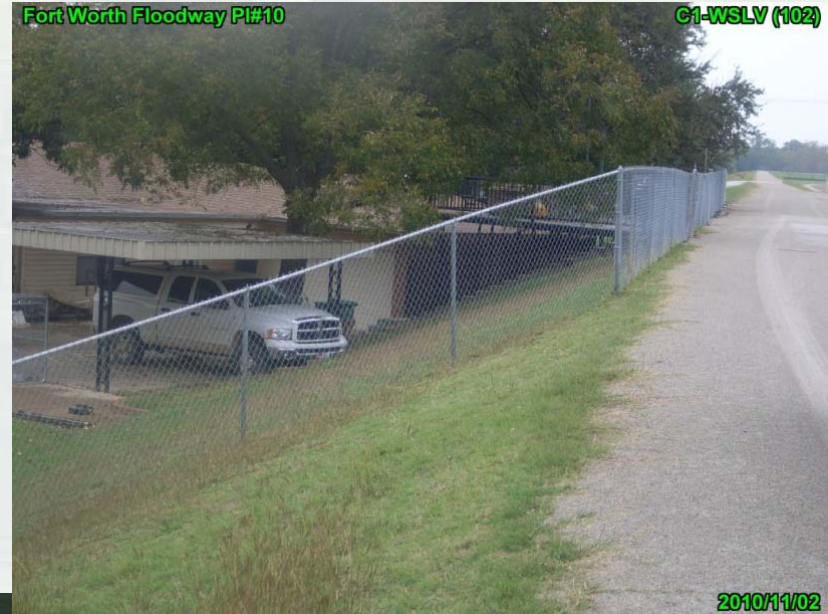
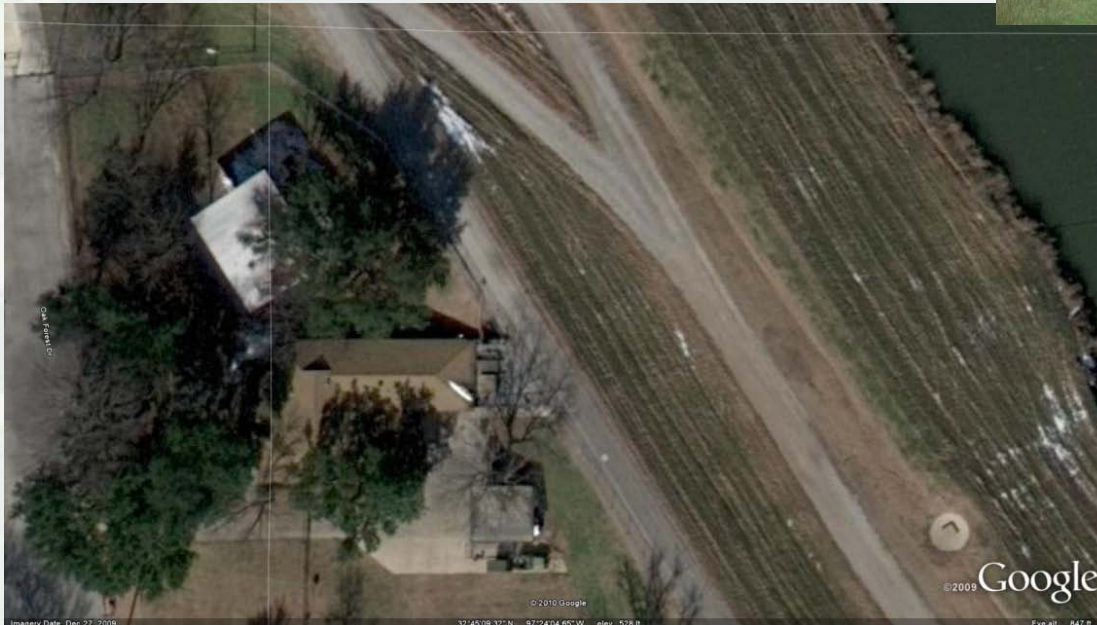
- Levee Embankment built into structure
- 1964 Design Plans indicate clearing
- 1968 SWF Correspondence to remove
- 1970 O&M Manual as Superintendant
- Sponsor has retained as the residence for Floodway Superintendant
- Being evaluated for Corrective Action

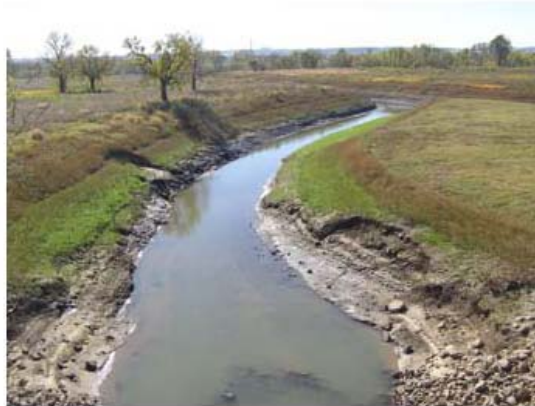
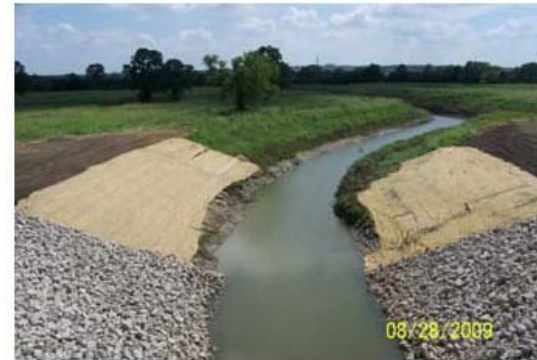
Corps. ID No. 074 – Hampton Pump Station, East Levee – There are slides on the right and left slopes downstream of the displaced riprap.

This item was repaired concurrently with the items in paragraph 2.1 and is further illustrated in the photos below.

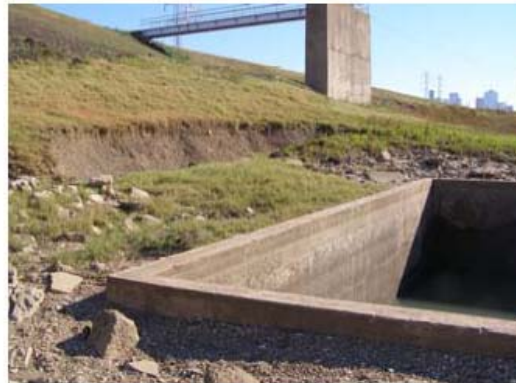
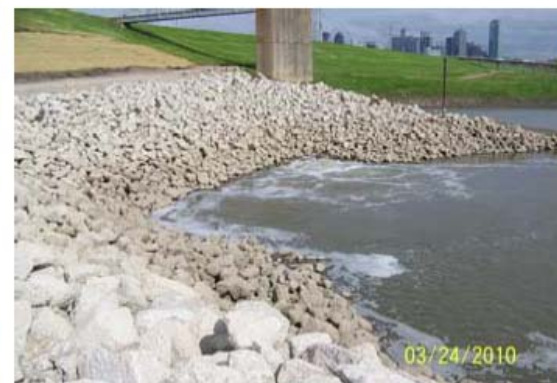
Corps. ID No. 062 – East Levee, Baker Pump Station – Erosion (4'W x 35'L) on the slope above the discharge chute, erosion (15'W x 35'L) on the left slope and erosion (50'W x 80'L) on the right side of the discharge channel.

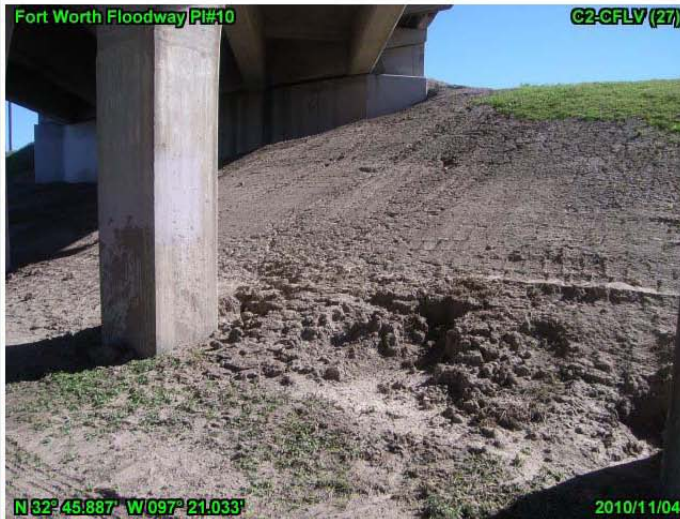
Figure J9-13: CFLV-0089 Erosion

- CFLV-0089: Erosion at SH 199 Bridge #1, corrected on 14 February 2011.
- CFLV-0007: Ramp for emergency drainage on L/S embankment, removed on 9 March 2011.

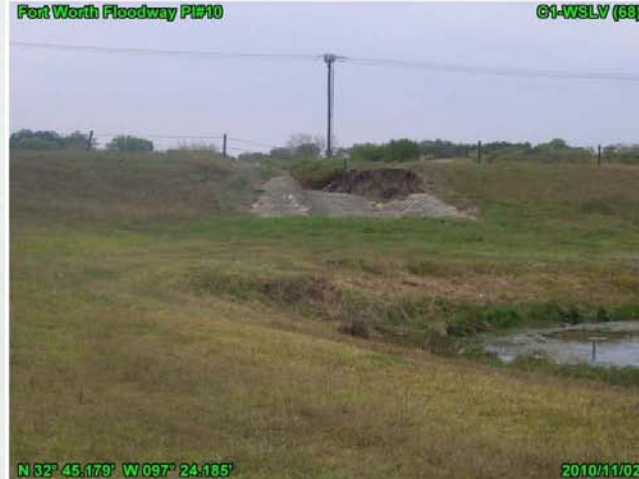
Figure F9-1: WSLV-0016 Tilting/Erosion

- **WSLV-0016: Tilting and deterioration of sump inlet**
  - Installed a PVC drainage culvert and repaired the eroded embankment
  - **Corrected on 23 February 2011**
