# Use of Technology for the Periodic Inspection of Flood Reduction Structures

**Fort Worth District**

**Dam & Levee Safety Program**

**1 December 2011**

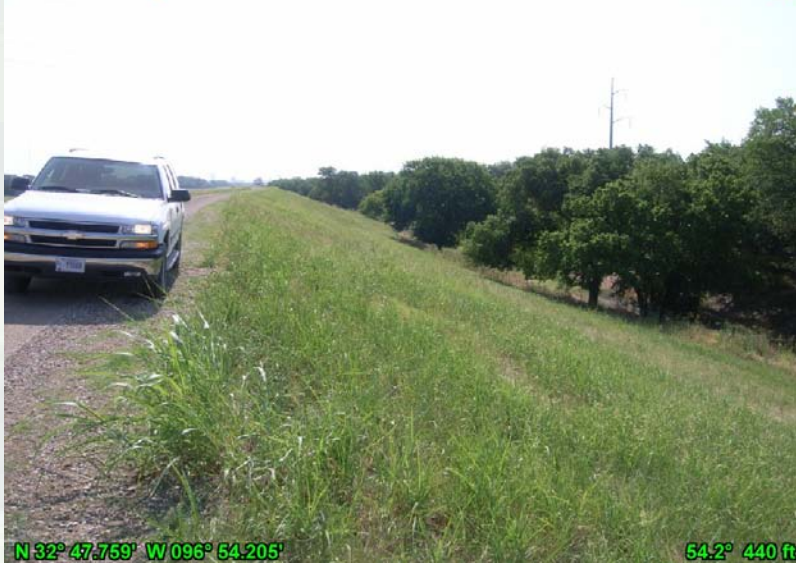
2010-06-23 (49)

DFS Tree Survey

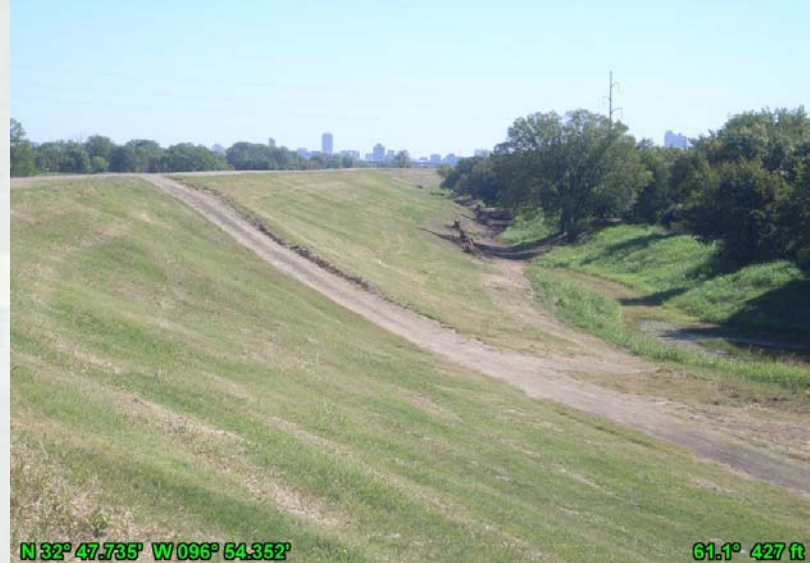
2010-10-14 (65)

DFS Tree Removal

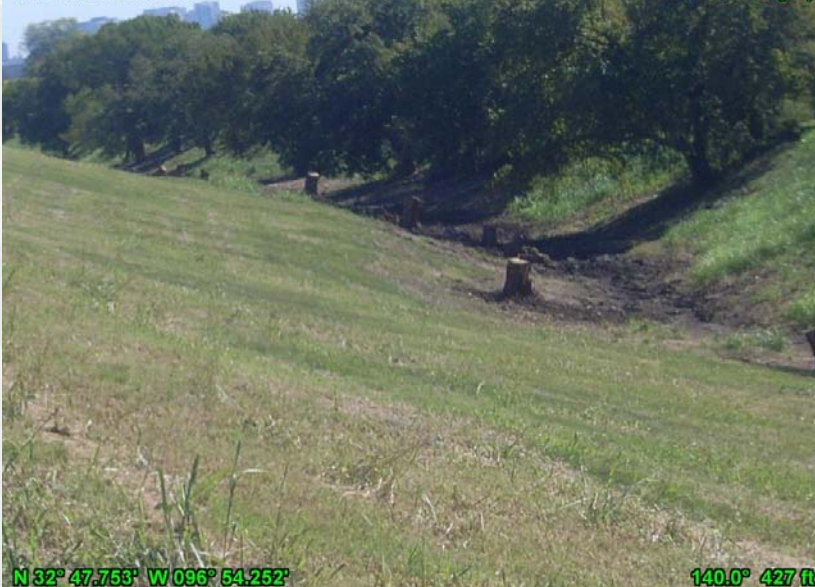
2010-10-14 (66)

DFS Tree Removal

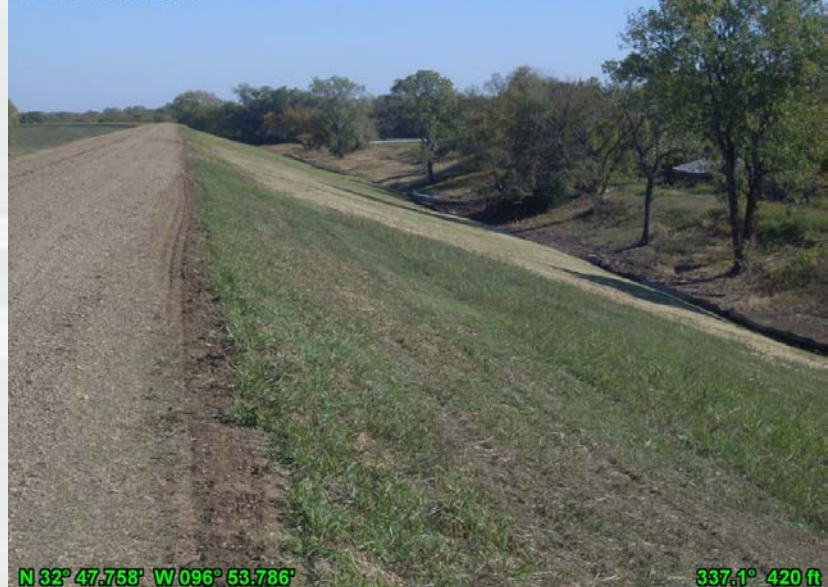
2010-11-19 (22)

DFS Tree Removal

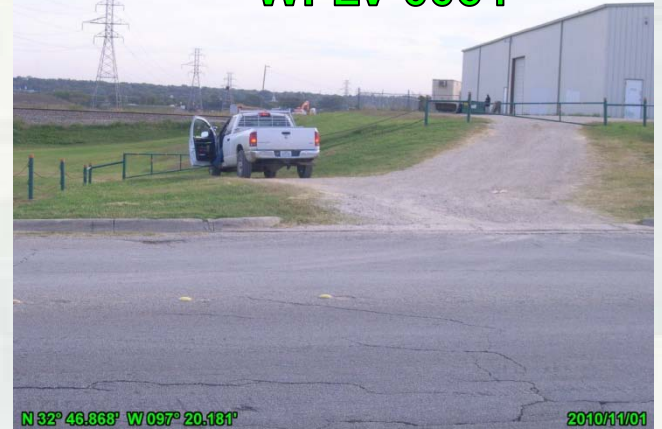
C1-WFLV (60)

- Private Buildings have been constructed on the levee embankment and adjacent to the levee toe.

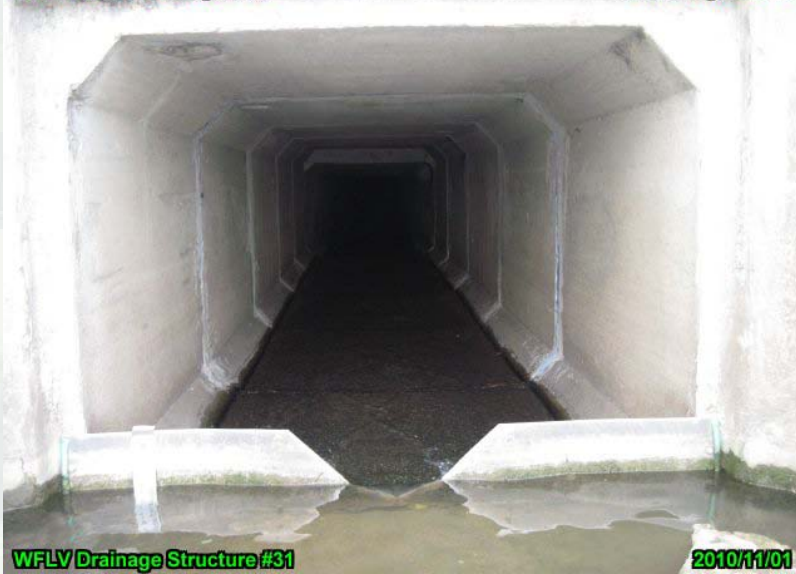
FtWFlidwy DS31-2

WFLV/Drainage Structure #31

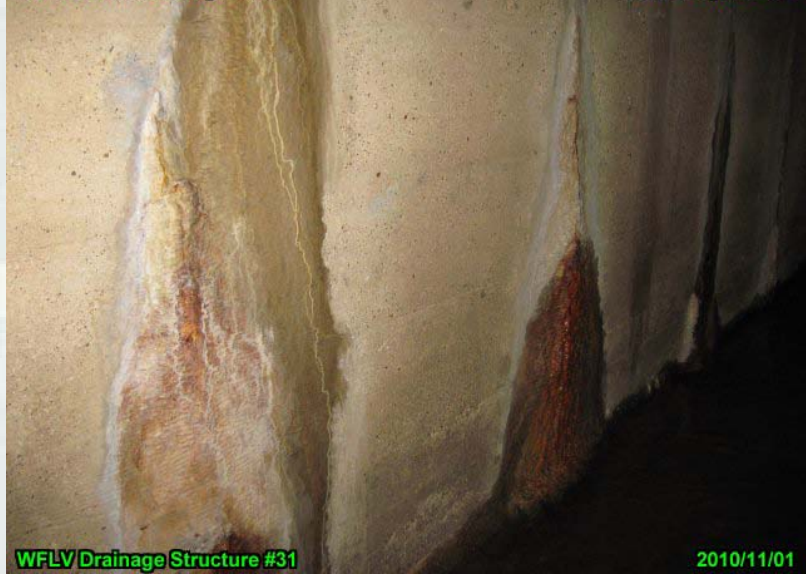
FtWFlidwy DS31-3

WFLV/Drainage Structure #31

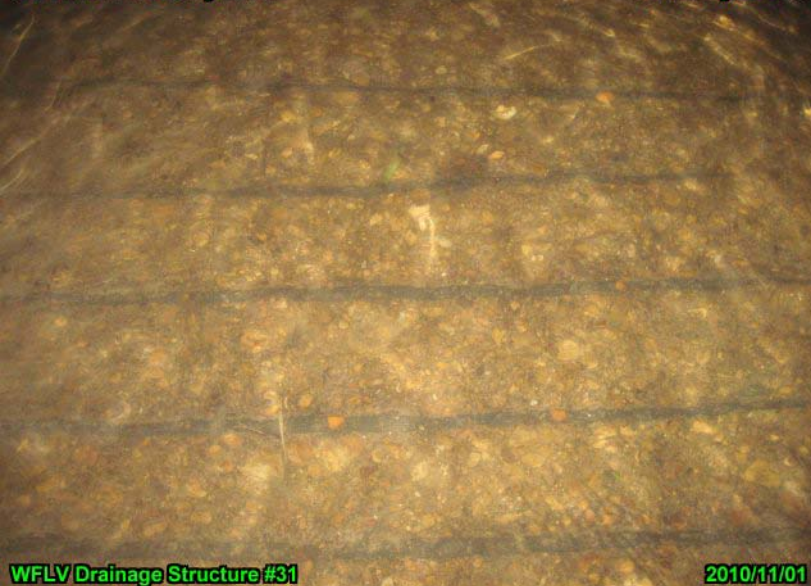
FtWFlidwy DS31-7

WFLV/Drainage Structure #31

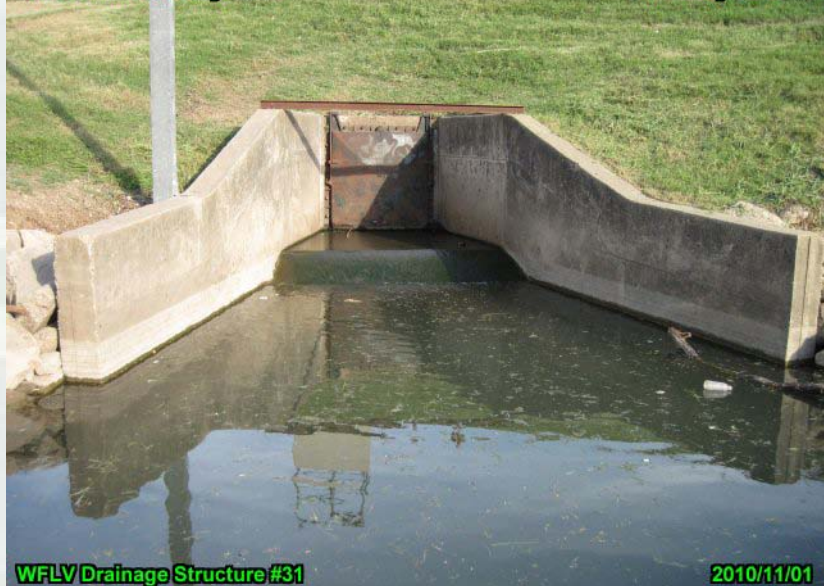
FtWFlidwy DS31-10

WFLV/Drainage Structure #31

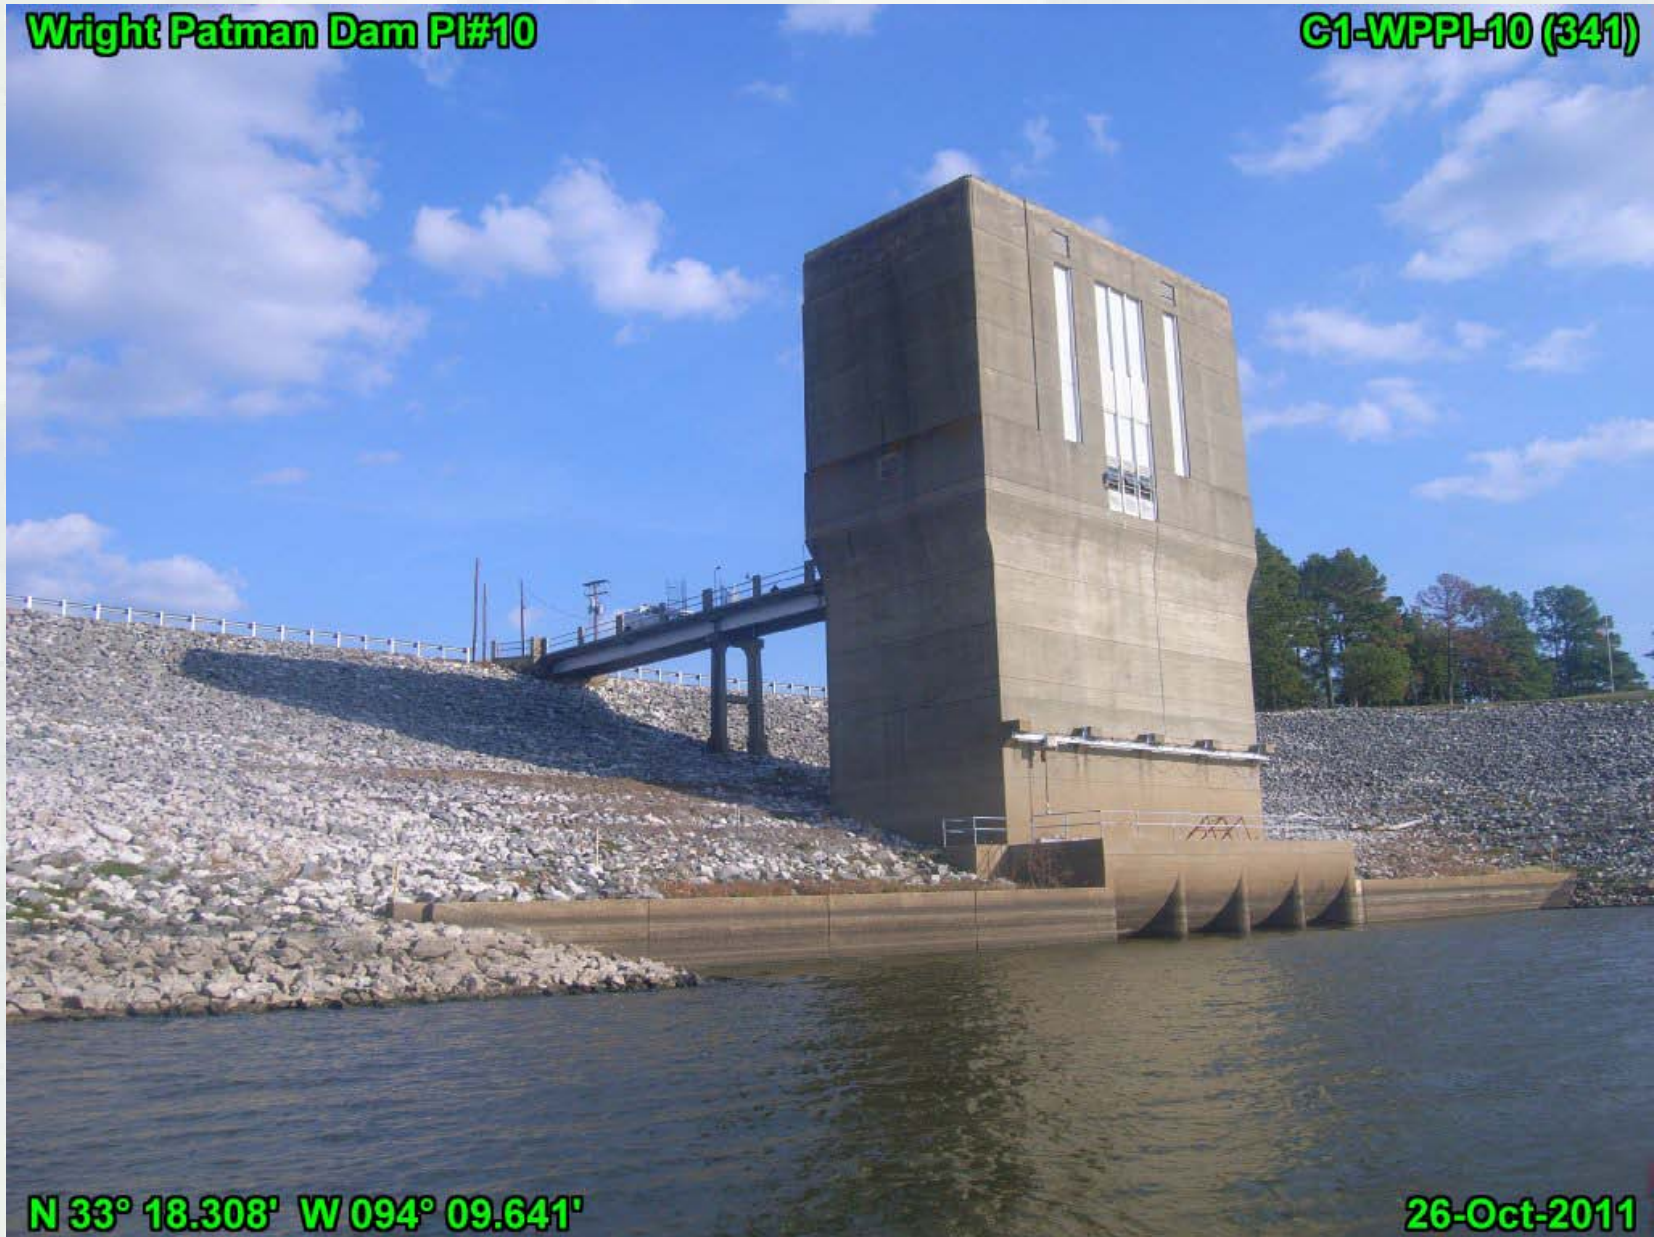
**C1-WPPI-10 (341)**

# Video Inspection of Upstream Rip Rap Erosion Protection

**Wright Patman Dam PI#10**
